E-Max Restoration on an Endodontically Treated Maxillary Lateral Incisor Using an Intra-Oral Digital Scanner

Case report (J Int Dent Med Res 2021; 14(3): 1132-1137)

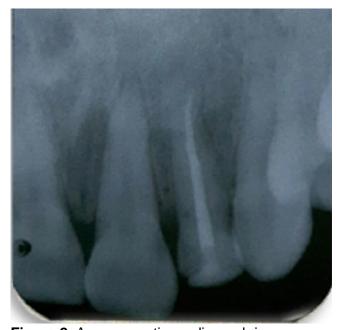
Figure 1. Preoperatif clinical picture.

A 21-year-old female patient visited the Department of Conservative Dentistry, RSGM FKG UNPAD. She wanted her fractured lateral incisor to get crown restoration and had endodontic treatment one week ago. She did not have a history of systemic disease and wanted to have her teeth repaired due to displeasing dental appearance. The examination on 22 revealed that a middle-third coronal fracture (Figure 1).

The diagnosis of 22 was previously treated tooth. The planned treatment for this case was an all-ceramic IPS e-max crown with a glass fibre-reinforced composite post (Luxapost, DMG).

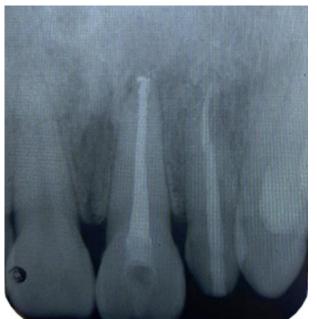
A radiographic photo was performed to confirm the fibre post placement (Figure 6).

Figure 6. A radiographic photo after the fibre post cementation.
