# Excellent Result of Revision Total Hip Replacement with Unexpected Metallosis

## Case Report

Hip Knee J. Vol. 2, No. 2, 2021, pp. 83-88

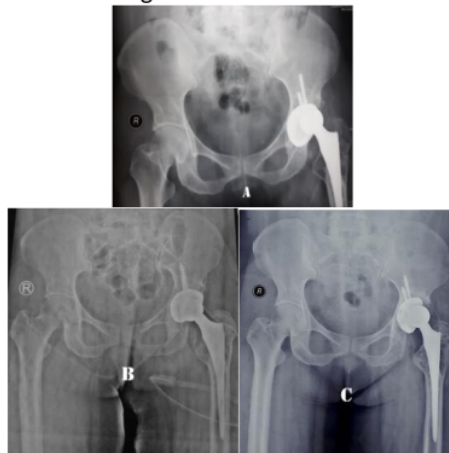
**Figure 1:** A) Pelvic radiograph before revision surgery showing osteolysis and amorphous density around the implant. B) Pelvic radiograph after revision surgery showing acetabular and femoral implant stable and fixed. C) Pelvic radiograph after 1-year follow-up showing acetabular component a little shear.

Hip radiographs revealed amorphous densities in the anterosuperior capsule and the posteromedial consistent with the "cloud sign" and curved radio densities around the acetabular cup and femoral stem, consistent with the "bubble sign." There was osteolysis with the loosening of both the acetabular and femoral components (figure 1A). Blood work was obtained, with CRP and ESR levels within the normal range. Given the severe pain, signs of osteolysis and unstable implant, the recommendation was made for the patient to undergo revision THR.

12  
The patient was allowed to be non-weight bearing using two crutches until 6-8 weeks. She was able to ambulate, perform quadriceps muscle strengthening and range of motion exercises with physical therapy, and was discharged on the third day postoperative. At eight weeks follow-ups, her incision was healed, she was ambulating good weight-bearing with an assistance device two crutches, and her range of motion was 0-110 degrees. After 1-year follow-up, the patient was able to ambulate without any device, the patient walked with a limp but no discrepancy, able to puts on shoes and socks with ease, railing climbing up the stairs without using the railing, comfortably sitting on the ordinary chair for one hour, no limitation walked distance but felt slight pain occasionally with no compromise inactivity. Patients could use a transportation bus and ride a motorcycle, patients able to rise from a squatting position without holding a device and normal activities sexual intercourse. Patients can feel fully flexion of the hip 140 degrees, abduction 20 degrees, adduction 10 degrees, and external rotations 15 degrees (figure 4). Pelvic radiograph performed after revision surgery and 1-year follow up an expected position with no evidence of hardware failure or loosening (figure 1BC). She reported that she was satisfied with her prosthesis.
