**THE 10<sup>th</sup> NATIONAL CONGRESS &  
THE 3<sup>rd</sup> INTERNATIONAL SCIENTIFIC MEETING (TINI III) OF  
THE INDONESIAN CONSERVATIVE DENTISTRY ASSOCIATION**

# Proceeding

# Management of traumatic immature teeth in maxillary incisor by aesthetic approach

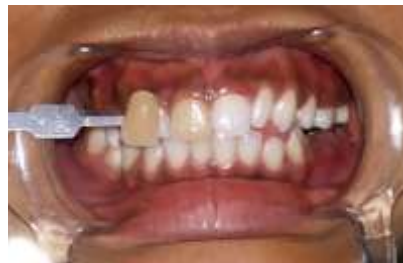
On the intraoral examination was seen blackish discoloration around the crown of tooth 11. Based on shade guide Vita 3D, tooth discoloration 5M 2 occurred on tooth 11. The occlusion examination shown normal occlusion with 2mm and overbite 2mm. The percussion and palpation were negative, there was no mobility, and the tissues around the tooth showed no abnormalities. According to vitality test, tooth 11 was non vital. There was no caries or fracture either on the crown or the root. On the dental periapical on tooth 11 was seen radiolucency and also unclosed the tip of apical (Picture 2). The clinical diagnosis for 11 tooth was discoloration which was caused by pulp necrosis and was accompanied by an open apex.

Picture 1. Clinical Features tooth 11 before the treatment.

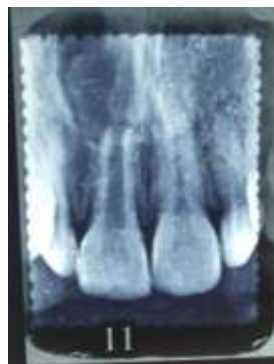
Picture 2. Radiographic initial overview of tooth 11

From the results of the vitality of the tooth 11 showed that non-vital tooth that need root canal treatment was carried out beforehand. In this case, it appeared that radiographic of the apical tio which was wide open so that it was necessary apexification used Mineral Trioxide Aggregate (MTA) to prevent overfilling of obturation material. Teeth with open apex could
