E-Max Restoration on an Endodontically Treated Maxillary Lateral Incisor Using an Intra-Oral Digital Scanner

Case report (J Int Dent Med Res 2021; 14(3): 1132-1137)

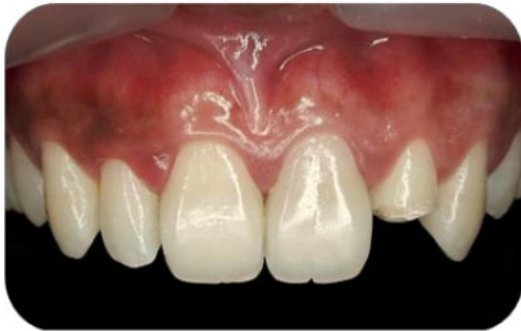
Figure 1. Preoperatif clinical picture.

⁶
A 21-year-old female patient visited the Department of Conservative Dentistry, RSGM FKG UNPAD. She wanted her fractured lateral incisor to get crown restoration and had endodontic treatment one week ago. She did not have a history of systemic disease and wanted to have her teeth repaired due to displeasing dental appearance. The examination on 22 revealed that a middle-third coronal fracture (Figure 1).

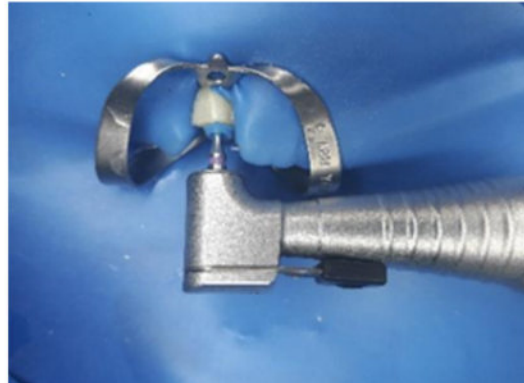
Figure 3. Guttapercha removal with the drill strength of 1.375 (luxapost, DMG).

At the second visit, a rubber dam was placed, and 2/3 of the guttapercha was removed coronally. Afterwards, 6 mm of the guttapercha remained in the root canal as an apical seal (Figure 3).

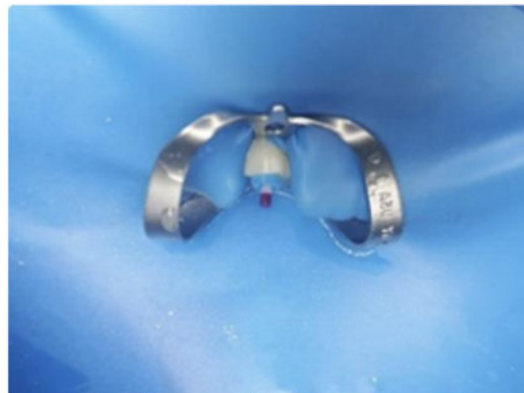
Figure 4. A fiber post trial.

A fibre post trial of was performed until the post fitted along the root canal (Figure 4).

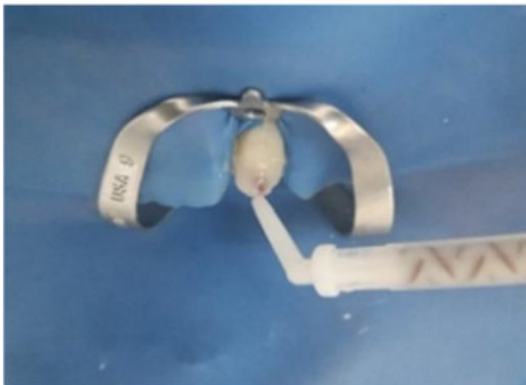
Figure 5. Core build-up using LuxaCore (LuxaCore, DMG).

The root canal was etched for 5 seconds, and tooth bonding was applied. The fibre post then was cemented into the root canal, and the core was built using luxacore (LuxaCore, DMG) on the crown (Figure 5).

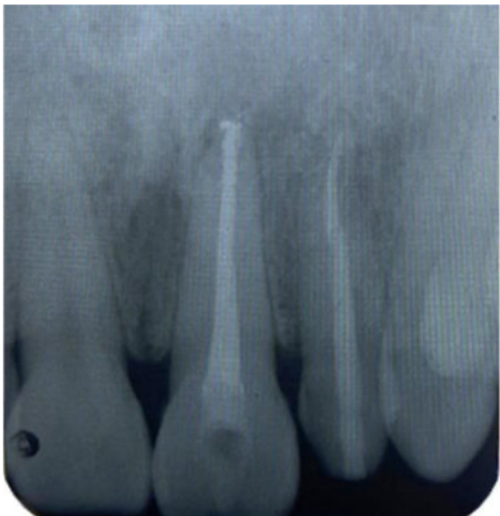
Figure 6. A radiographic photo after the fibre post cementation.

A radiographic photo was performed to confirm the fibre post placement (Figure 6).

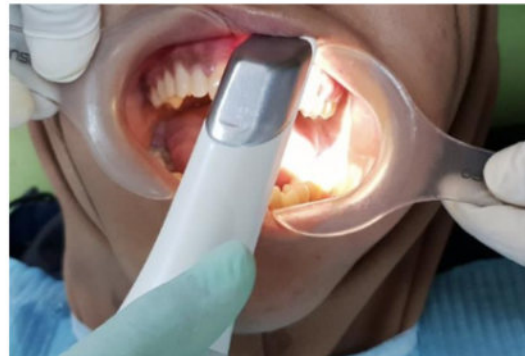
Figure 8. Virtual intraoral scanning/printing with a digital intra-oral scanner.

Imaging results were obtained from the use of intra-oral digital scanner (Figure 8)

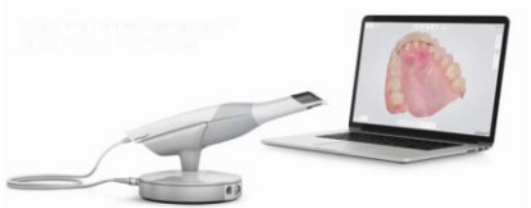
Figure 9. Digital intra-oral scanner (3-shape, TRIOS).

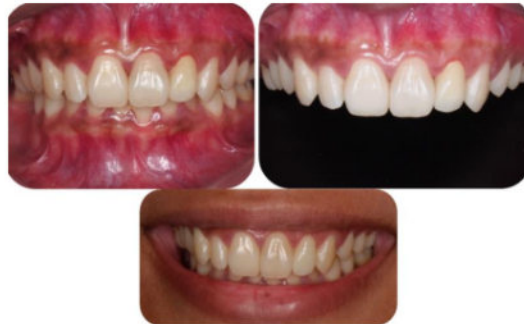
Figure 12. Post e-max crown insertion into tooth 22.

At the fourth visit, the e-max was cemented using dual-cure resin cement (RelyXTMU200, 3MESPE) (Figure 12).
